**Final Report**  
**San Vicente Creek River Stewardship Project Phase 1**  
**June 15, 2024**  
**Submitted by Gila Resources Information Project**

**GRIP San Vicente Creek Restoration Project  
GRIP Phase I Management Units  
(svc001-011 & AgA001)**

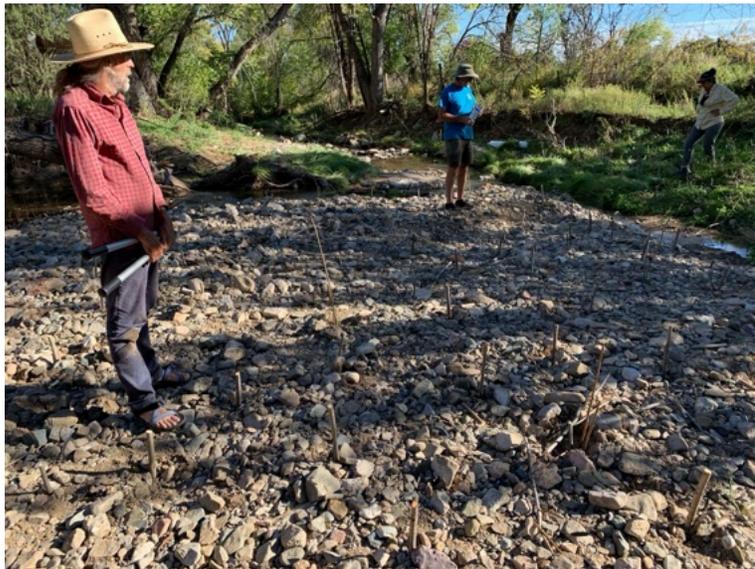
Planting willow whips along San Vicente Creek. Planted willow whips poke up on the gravel bar at the downed cottonwood. October 13, 2022

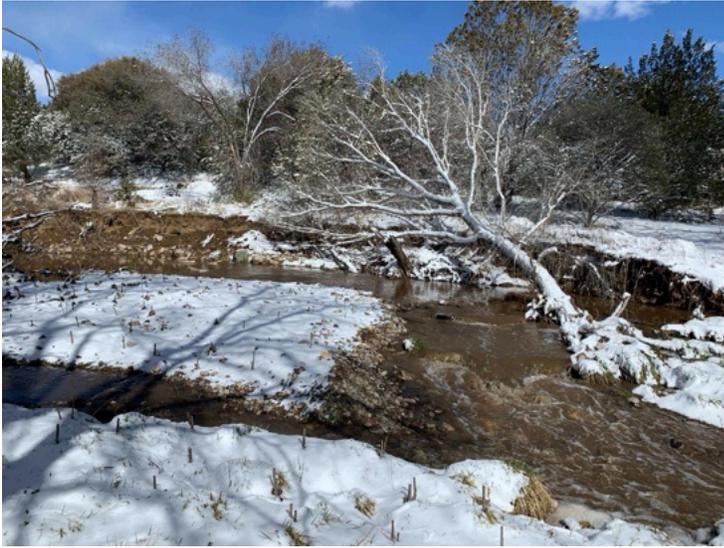
Willow whips on cobble bar - February 2023

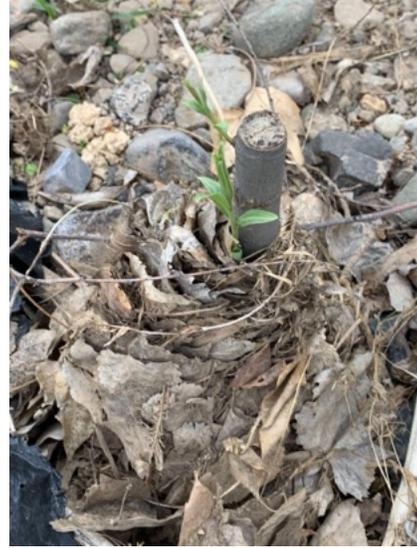
Willow sprout - April 2023

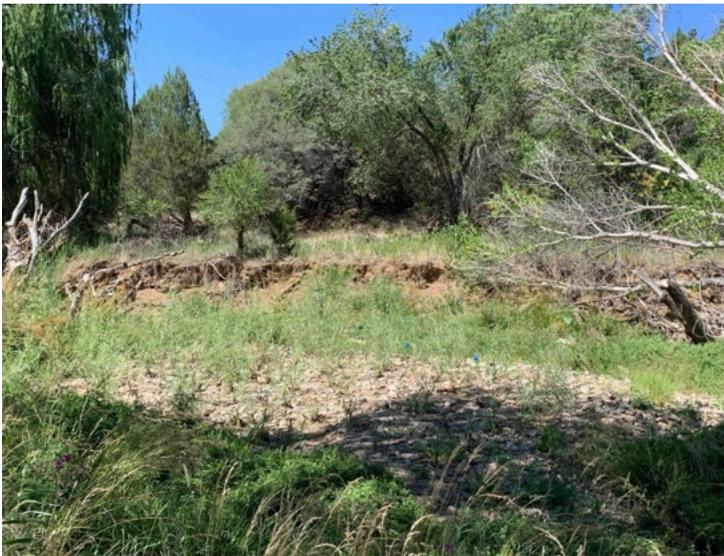
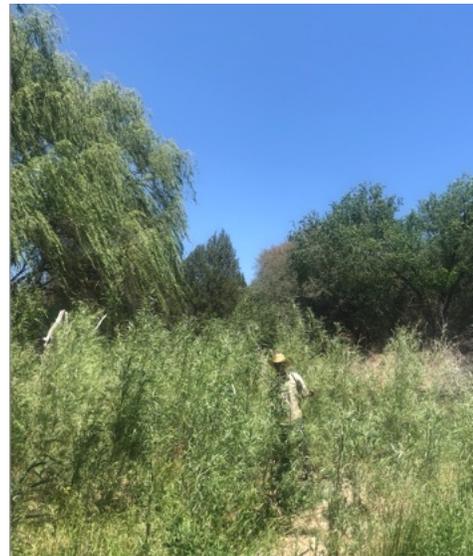
Willow whips on cobble bar - June 24, 2023 and May 2024.

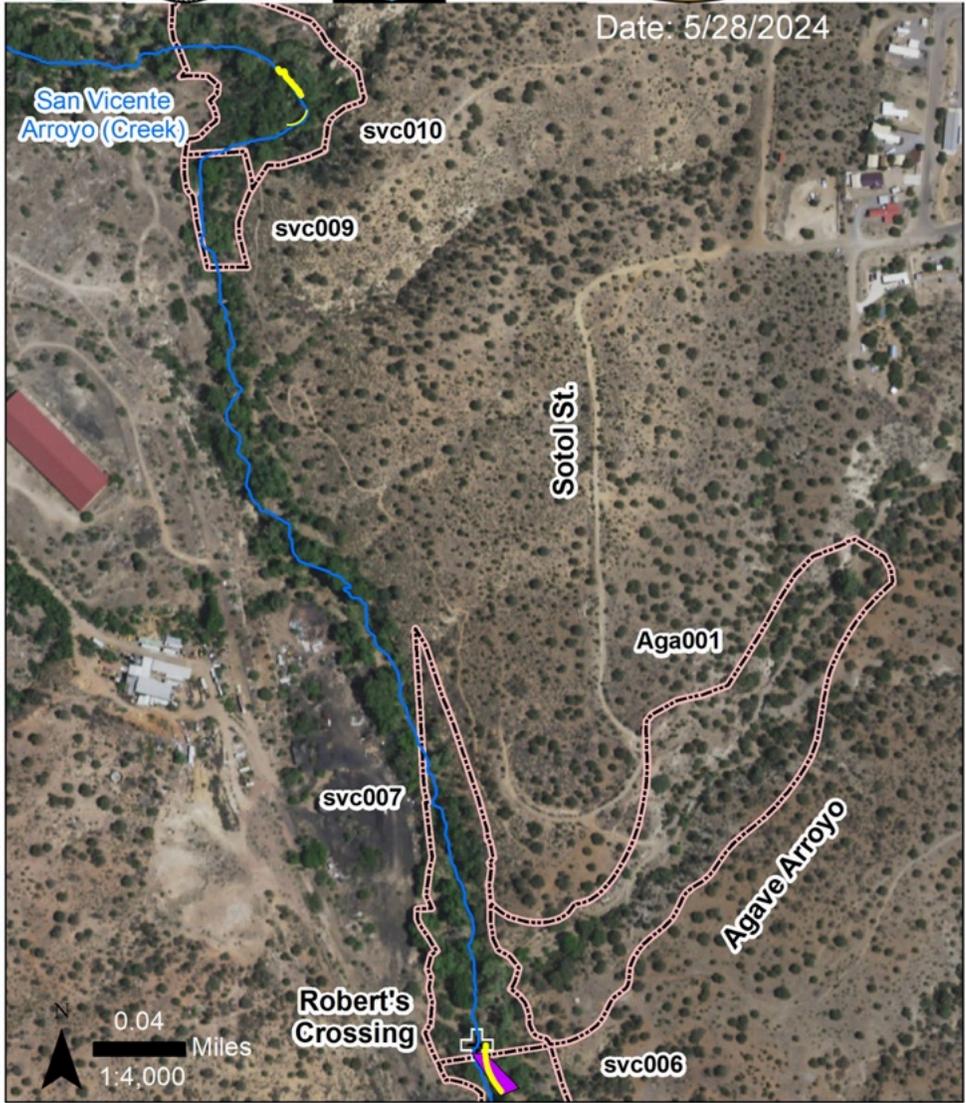
**GRIP San Vicente Creek Restoration Project**  
**Figure 4** Willow, Native Tree & Shrub Planting Areas  
**North**

See Figures 4 and 5 for willow/cottonwood plantings (yellow lines) in the project area.

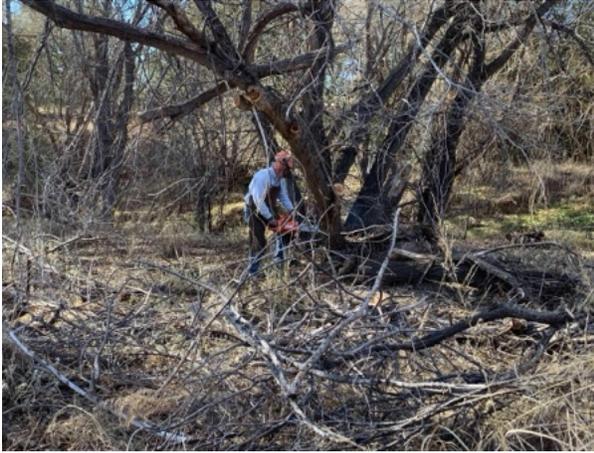
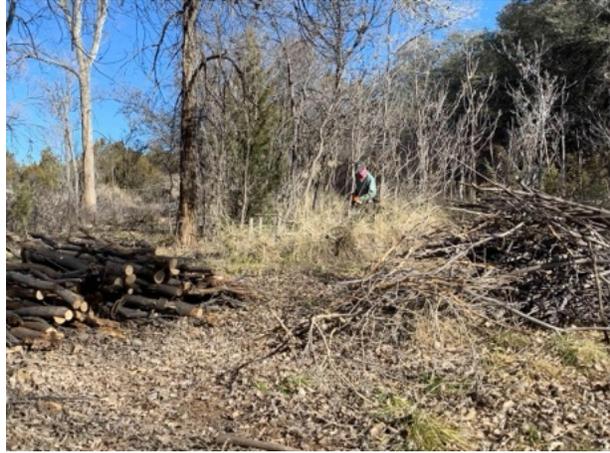
Gila WoodNet and Stream Dynamic elm and Tree of Heaven removal in lower area of San Vicente Creek - February 2023

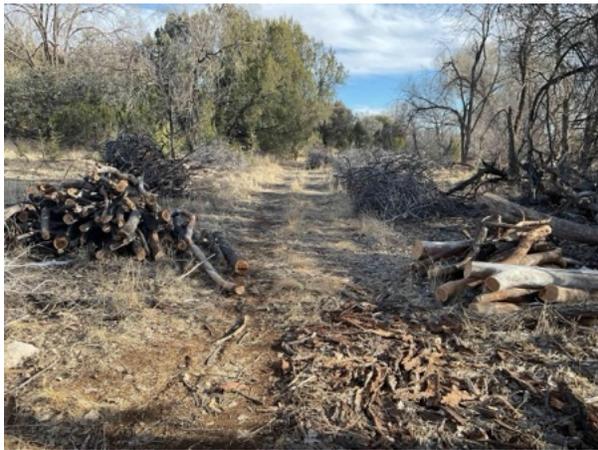
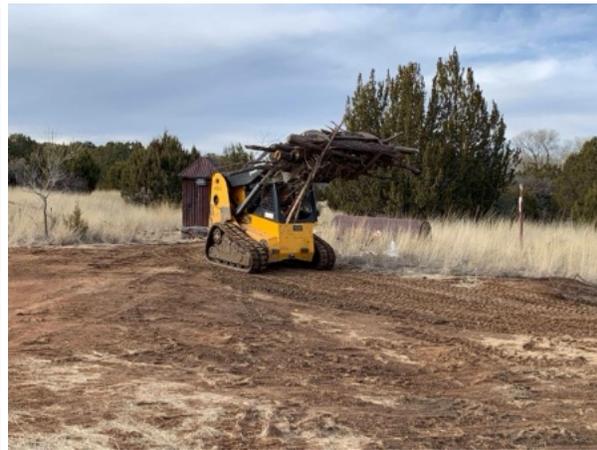
Cut biomass was stacked along access roads to facilitate pickup by either the grapple logging equipment or loader. Biomass was hauled to Old Chinese Gardens for processing into chips, biochar or firewood. January - March 2023

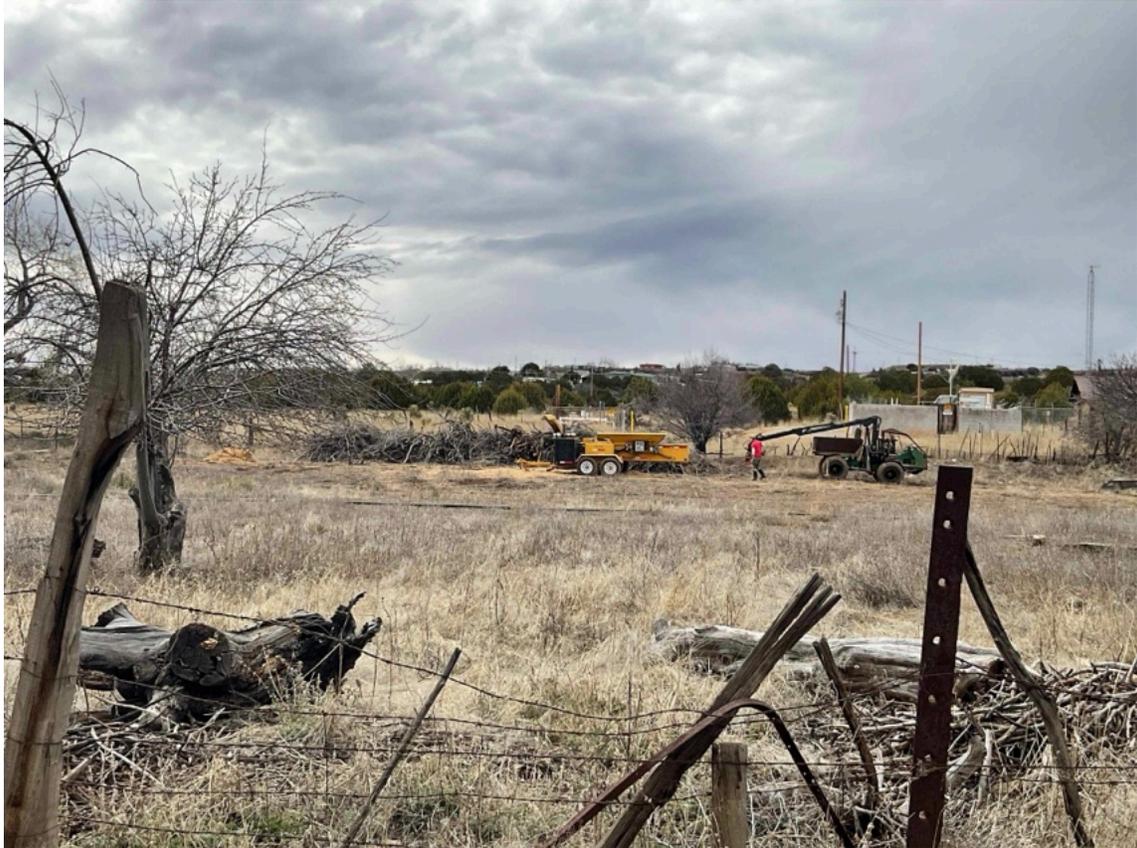
Gila WoodNet processed biomass at Old Chinese Gardens farm. The grinder processed biomass into mulch that was used in access road rehab and plantings and compost. Larger logs were used for biochar and firewood. February 2023.

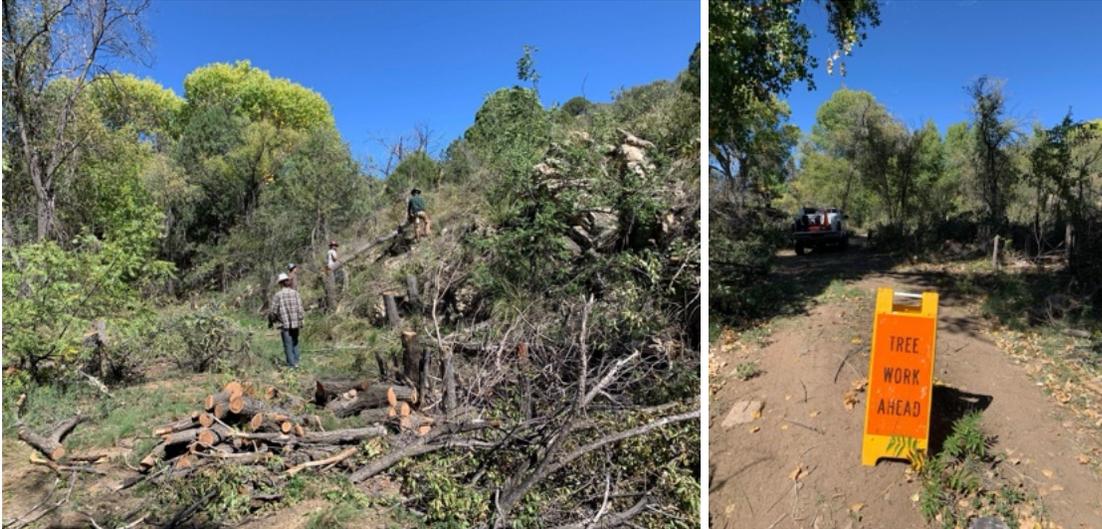
Southwest Tree Solutions cut Siberian elm and Tree of Heaven from SVC-009 through SVC-011 in October 2023. Large logs were hauled from the project area. Some of the chips were distributed on the project site.

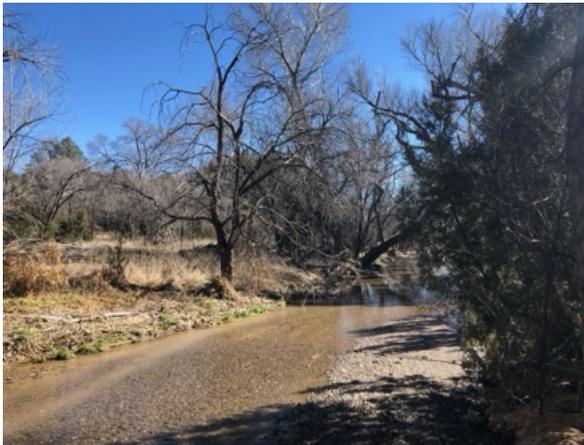
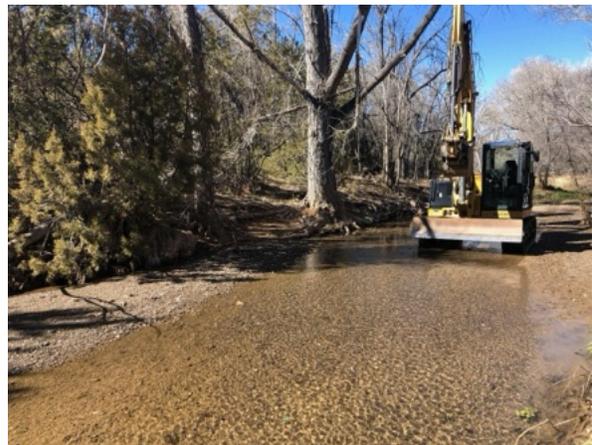
Robert's Crossing Grade Control Before - looking downstream and looking upstream.  
January 2023

GRIP and Stream Dynamics constructed a boulder grade control structure to stabilize the utility access at "Robert's Crossing" during the next large flood. The grade control was built in anticipation of a headcut that will occur when the log jam gives out. (We ended up removing the log jam when we stabilized the bank in this vicinity to protect the sewer line in Phase 2.) We anticipate that the next large flood will remove the sediment that had accumulated behind the log jam, and our grade control structure will create a plunge pool and riparian habitat, while also protecting the grade of the stream at the crossing. The banks along the structure were stabilized with plantings of coyote willow, Goodding's willow and cottonwood. The Goodding's willow and cottonwood posts were planted directly into groundwater with holes dug with an auger.

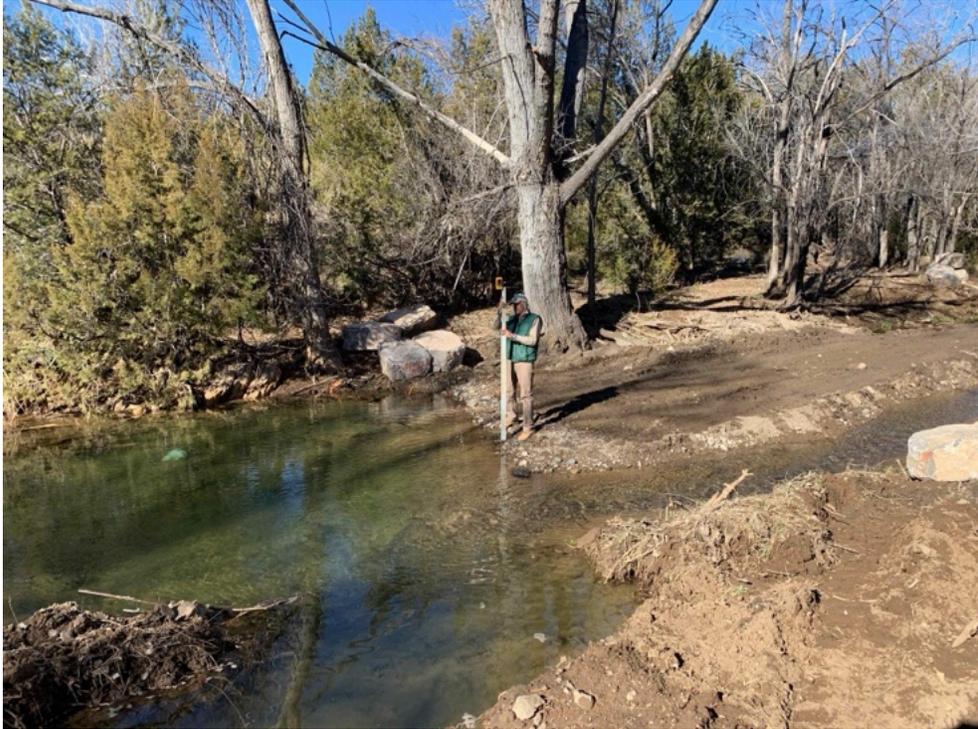
Robert's Crossing grade control construction - January 31

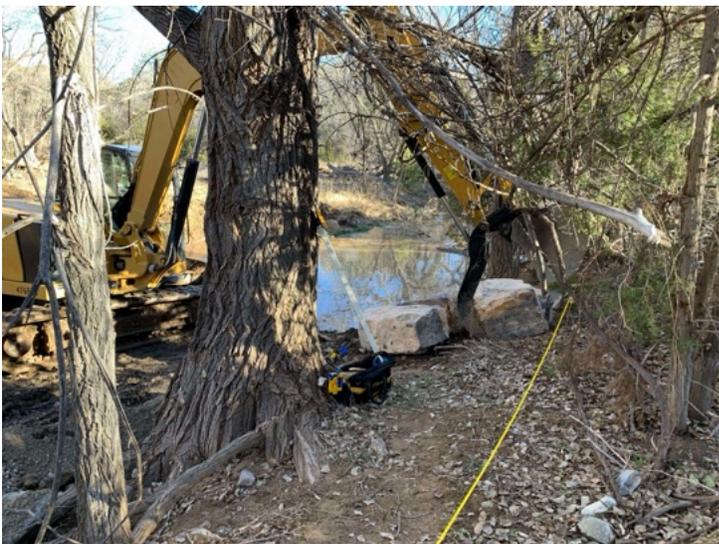
Placing the rock for the grade control structure.

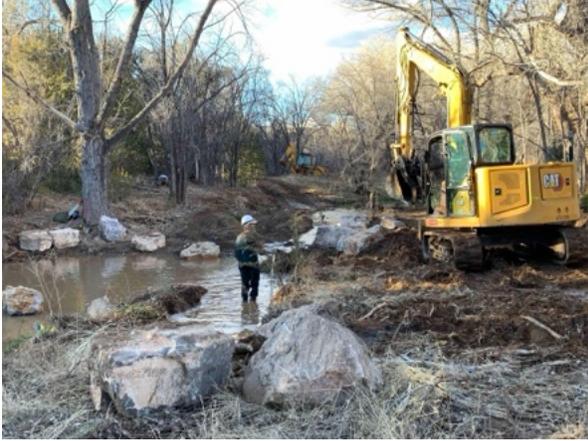
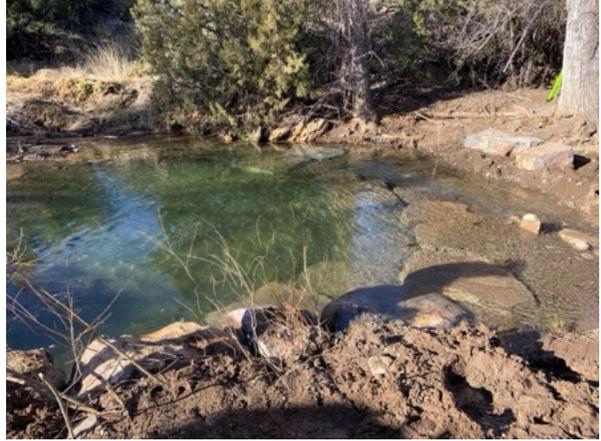
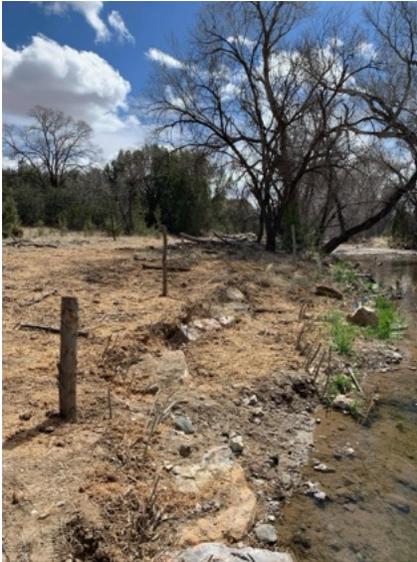
Goodding's willows and cottonwood posts can be seen on the left bank along the cross-vane grade control structure. Coyote willow planted on the inside of the structure.

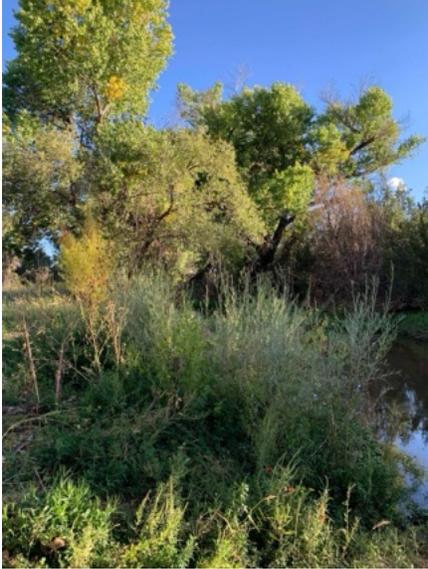
Coyote willows, Goodding's willows, and cottonwoods at cross vane grade control structure (L). Pole planted Goodding's willow at Robert's Crossing. October 2023

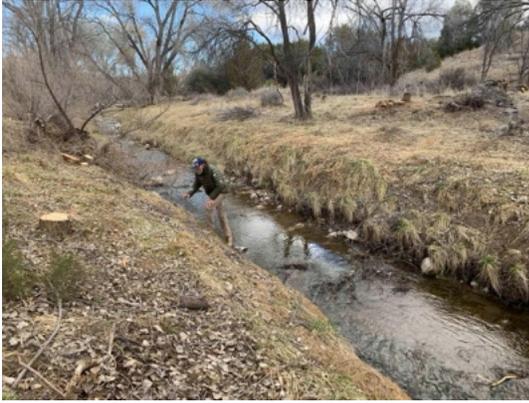
### Log Vane - BEFORE/CONSTRUCTION

A log vane structure was constructed to induce meandering of the creek away from the sewer line in the vicinity of Old Chinese Gardens. The Town of Silver City had previously constructed an access route along the stream bank in this area, without the private property owner's knowledge, to address a sewer line overflow in 2020. Since that time this bank has been eroding badly. Stream Dynamics used an excavator to carry the bole of a large cottonwood tree, that had been illegally cut down in the vicinity of Robert's Crossing, and brought it to this site. We excavated a shallow trench in the stream bed and bank, and set the log in as an upstream pointing barb with the but end embedded into the right bank at bankfull elevation. It was held down by a large boulder, backfilled with gravel and sediment, and then planted with willow whips. The sediment used to hold the log vane down was obtained by recontouring the opposite bank to be vertical, and more prone to erosion. Unfortunately, the private property owner Old Chinese Gardens LLC decided that they did not want us to breach the berm on their property to reconnect the creek to the floodplain. We therefore removed this task from the workplan.

The log vane has been through a few sub-bankfull events, which have caused a small amount of erosion of the opposite bank (river left) and a small amount of deposition on the near bank (river right). This is exactly what was intended. The willows that were pole planted in the back fill of the log vane are doing great, averaging about 3 feet high. This natural infrastructure is in good shape, but it remains to be tested by a very large runoff event. There have been no significant storms since the building of the log vane.

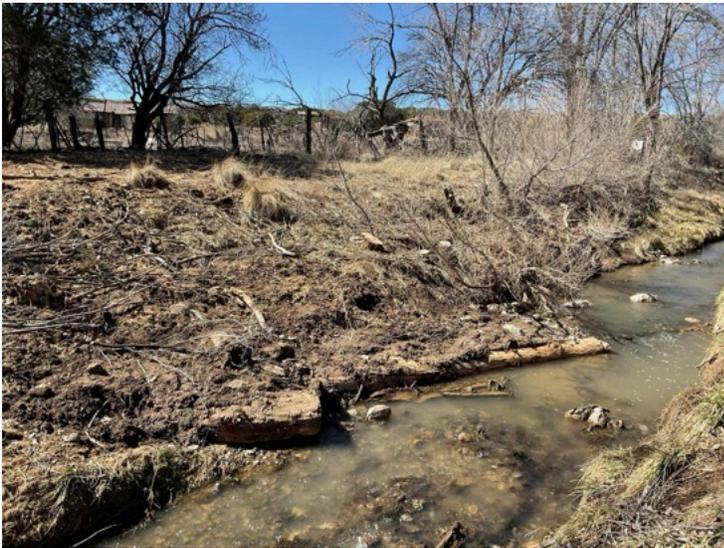
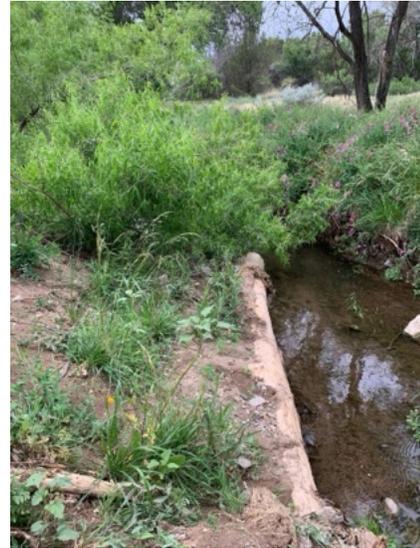
### Log Vane - AFTER

February 2023

June 2023

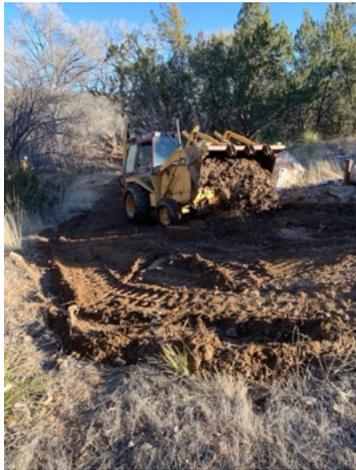
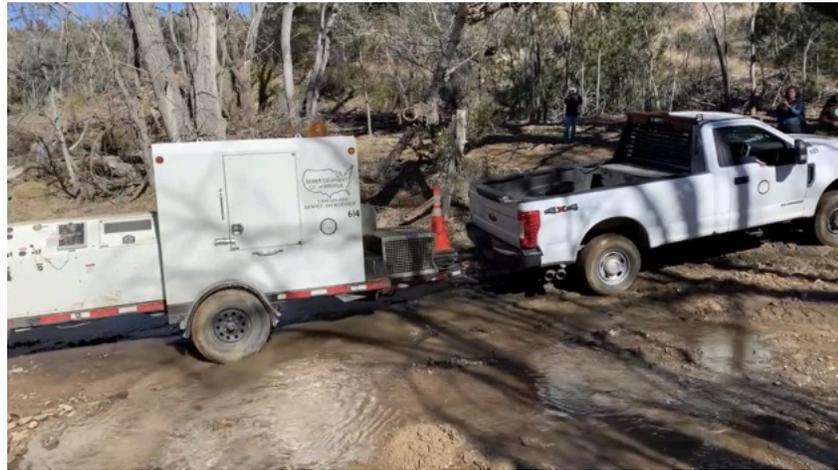
Regrading and repair of access route at Robert's Crossing (L). Town of Silver City Utilities Department tests Robert's Crossing and access route at completion of our work. February 2023. (R)

The steep-sloped access road to Robert's Crossing that had been eroded into a deep V profile was filled in, repaired and contoured with three rolling dips to direct stormwater off the road to prevent gullying and to direct stormwater runoff from going directly into the creek. Stream Dynamics applied gravel to the road bed. At the conclusion of work, volunteers picked up three truck loads of trash from the area, seeded and mulched the access road and water drainage areas. Trees were removed to provide adequate access to the Utilities Dept. equipment to manholes. All access routes were restored, including reseeding and mulching.

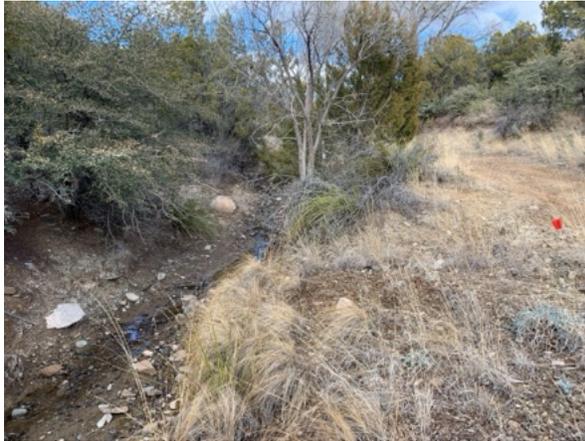
Before

## Agave Arroyo Check Dams

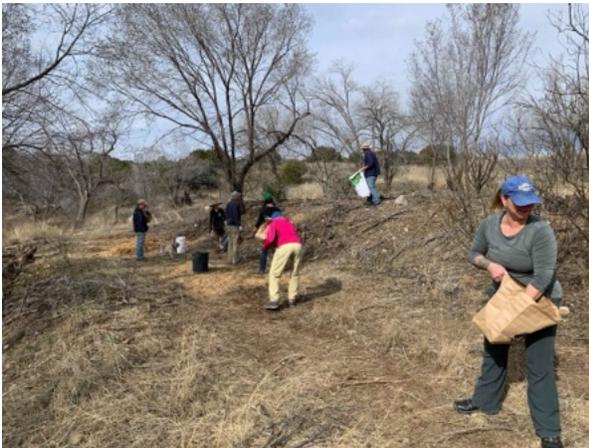
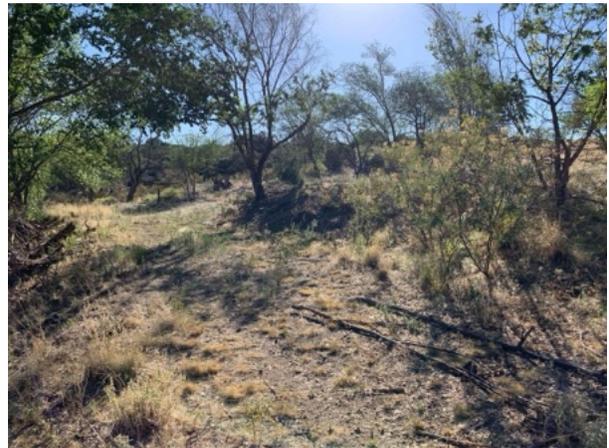
Re-seeding at SVC-001 -(TOH thicket) (Feb 2023) Access road at SVC-001 (TOH thicket) June 2024

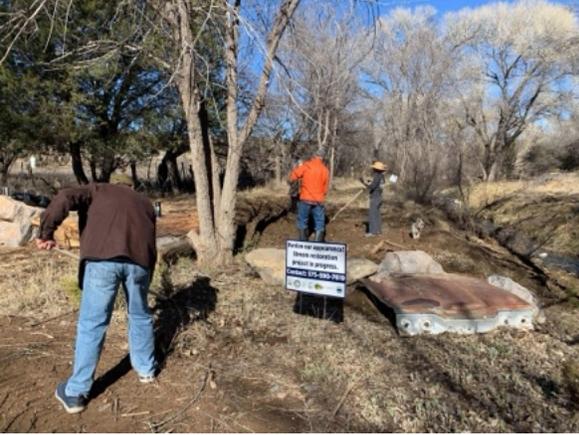
Reseeding at the Log Vane site (February 2023)

Reseeding and mulching of the access roads and disturbed areas was successful at re-establishing vegetation and restoring the disturbance caused by heavy equipment.

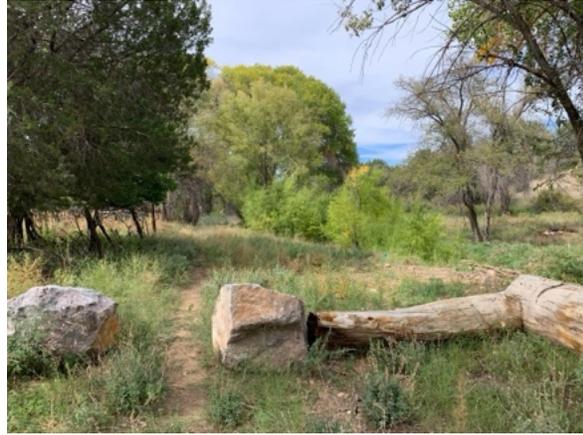
Log vane site (October 2023)

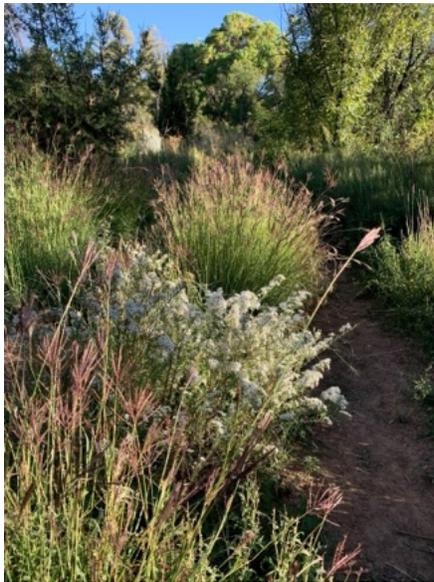
Access road in SVC-006 is full of native grasses and wildflowers. October 2023.

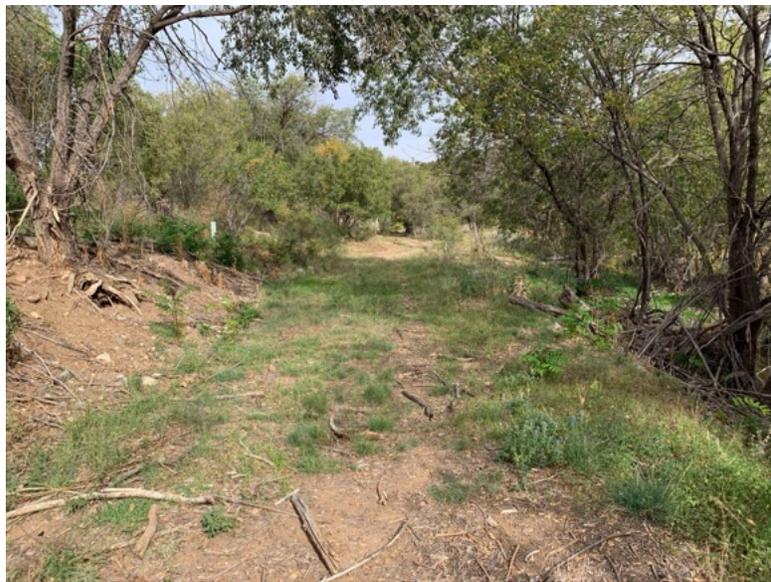
Access road in SVC-001 at Tree of Heaven thicket looking to the east revegetated with grasses. October 2023.

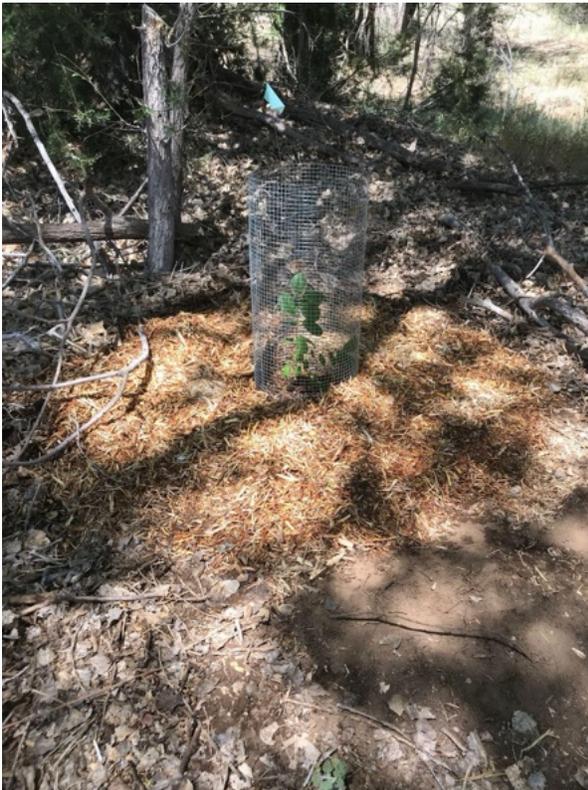
Chokecherry with large mulched basin and hardware cloth to protect from deer/goat browse. May 2023

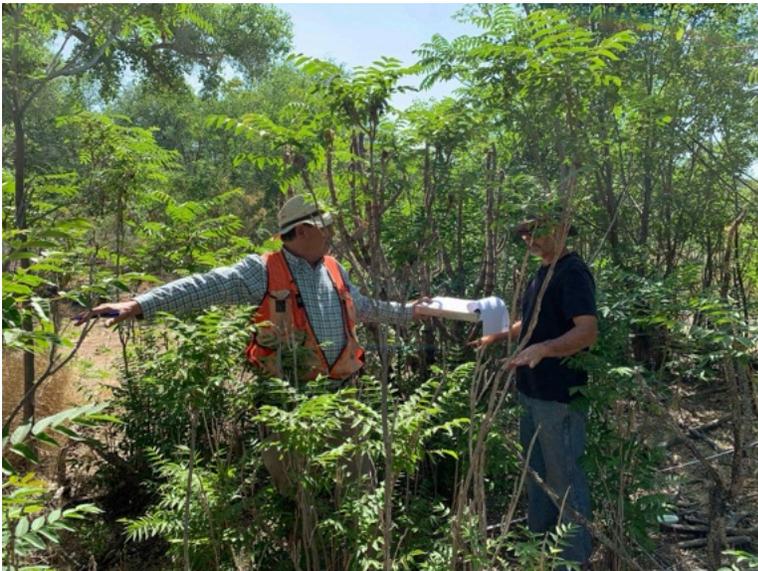
SVC-001 Fuel load and vegetation survey in Tree of Heaven thicket. June 2022

The Tree of Heaven thicket in SVC-001 was the worst thicket in the project area.

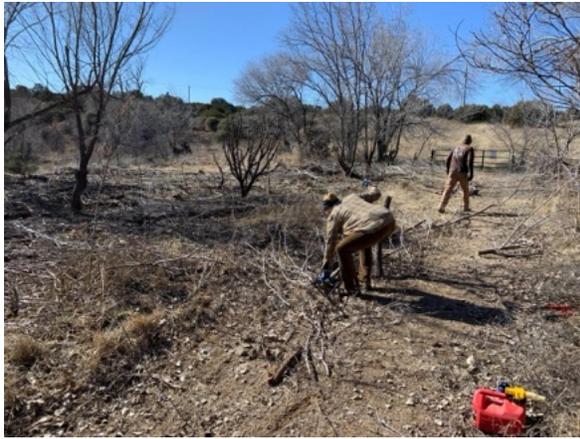
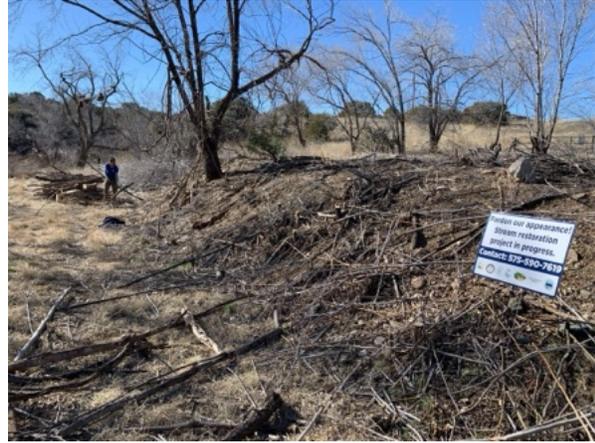
SVC-001 Cutting of Tree of Heaven thicket. January 2023

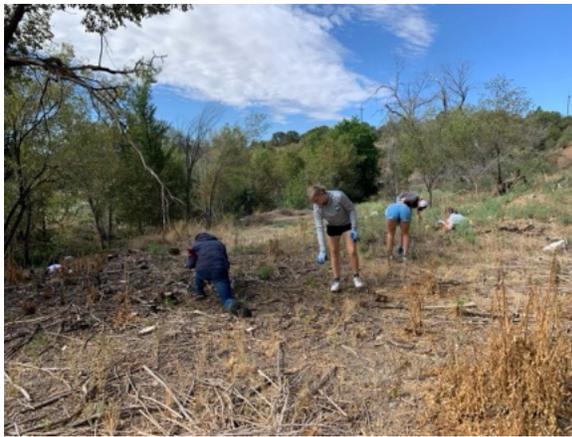
YCC EcoMonitors cut and hand pull resprouts in SVC-001 Tree of Heaven thicket. August 2023

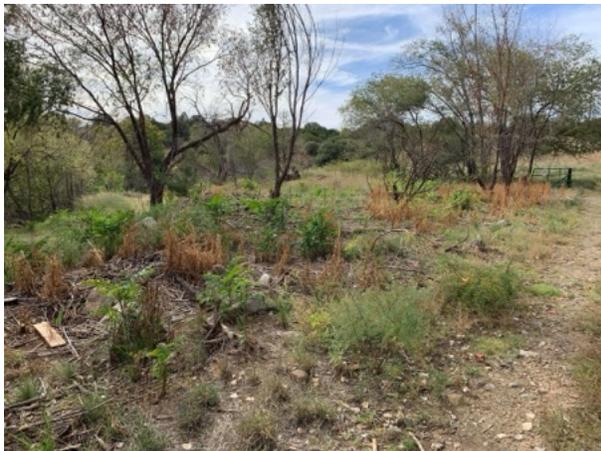
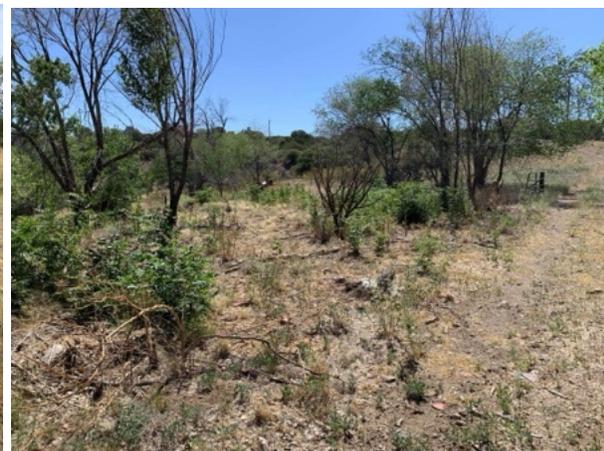
SVC001 - Tree of Heaven thicket looking west - post-herbicide application #1 (Oct 21, 2023)

SVC-001 - Tree of Heaven thicket looking west - June 2024

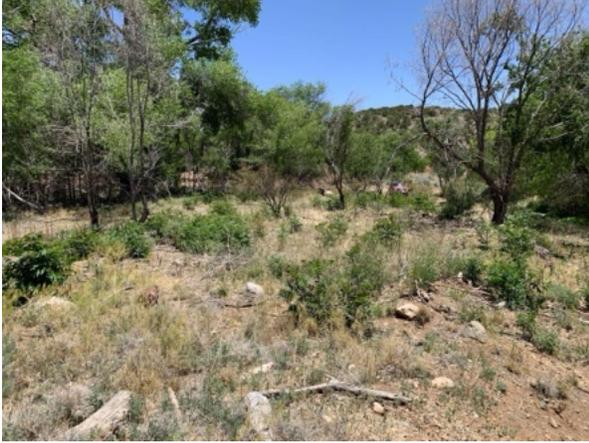
SVC-001-Tree of Heaven thicket looking east  
May 25, 2024

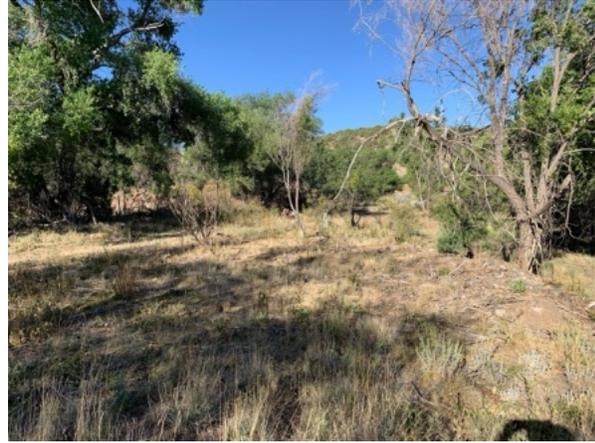
SVC-001 - Tree of Heaven thicket looking east  
June 15, 2024 after herbicide treatment #2

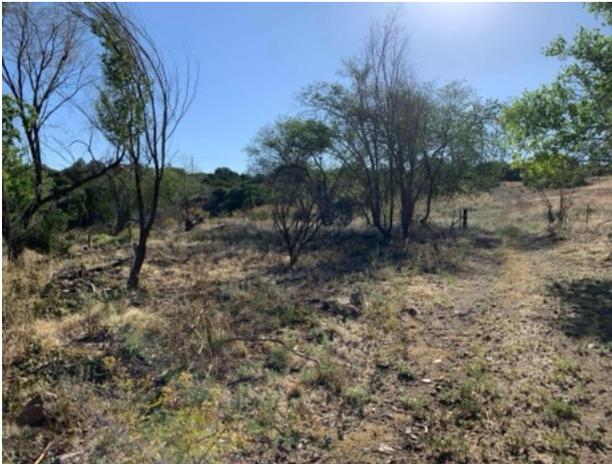
SVC-001 Tree of Heaven looking west - post-herbicide  
application #2 (June 15, 2024)

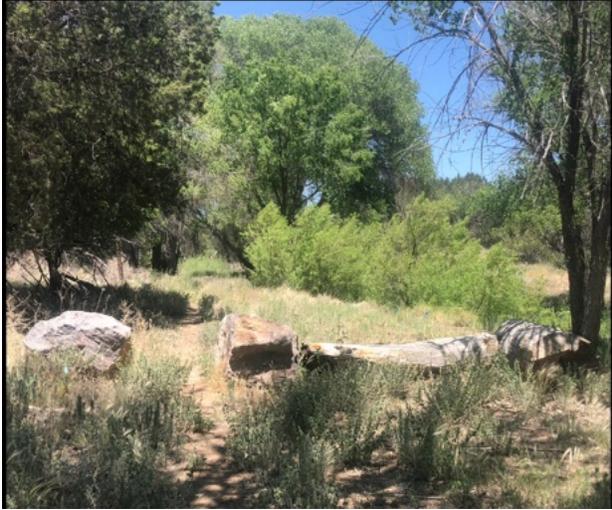
May 2024

The tree we used to build the log vane had been growing upstream about 2000 feet when it was illegally cut by squatters on 93 North LLC and Nuevo Principio property. Our sawyers cleaned up the mess and Van Clothier of Stream Dynamics hauled this giant branch with the excavator to the site via the old railroad grade. Once at the vane site, it was custom cut to fit into the bank, leaving two big chunks. These were used in conjunction with the last two boulders we had to block illegal vehicle access. This is immediately downstream of the log vane site on river right. It is quite apparent that this has effectively blocked access ever since construction.

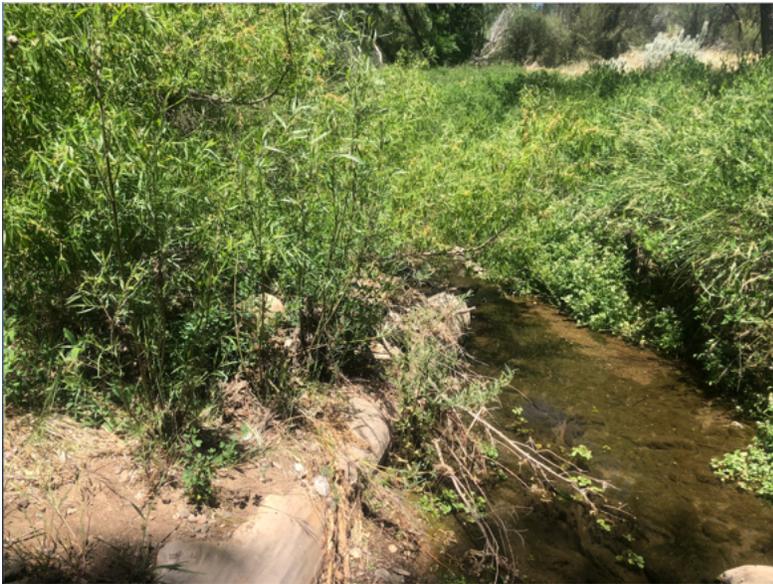
May 2024

At the time of construction, the left bank (on the right side of this photo which is looking up the creek) was intentionally undercut with the excavator to increase its erodibility. Everything looks good so far and native dace are present in the pool. Hopefully we will get a decent monsoon this summer and this structure will be put to a proper test.

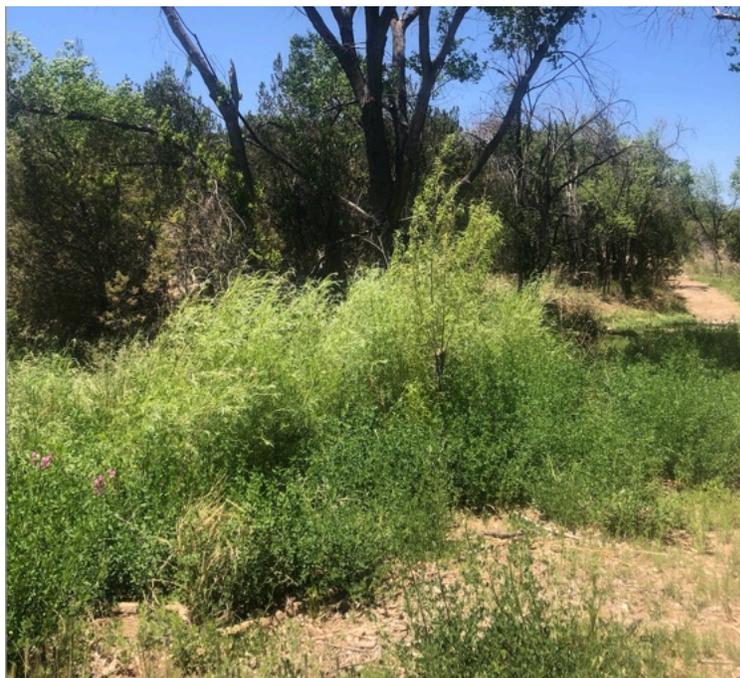
May 2024

The Goodding's willows and coyote willows that were planted on the left bank among the boulders of the grade control structure are doing great. They average about 6 feet high.

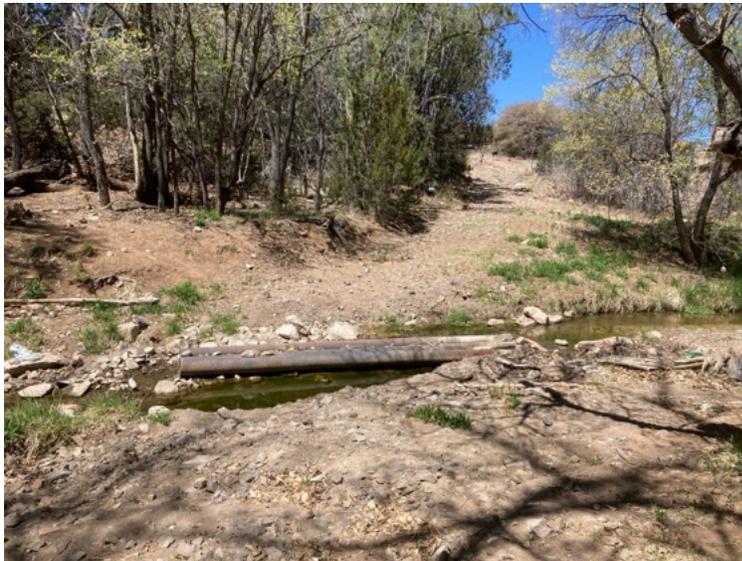
In the photo below, you can see that the improved access route at Robert's Crossing is doing great. Before the project, this steep section of road had cut a deep V because it was carrying stormwater from the old railroad grade all the way into the creek. (See the first photo below.) Being a rather steep road, the steep V profile made it treacherous to even walk. The erosion was filled in with the material that came from removing a berm next to the large cottonwood on the other side of the creek. Removing this berm improved floodplain access in the vicinity of Robert's Crossing and took pressure off the grade control structure. In order to stabilize the new roadbed, we built three rolling dips.

**BEFORE (2021)**

**AFTER (2023)**

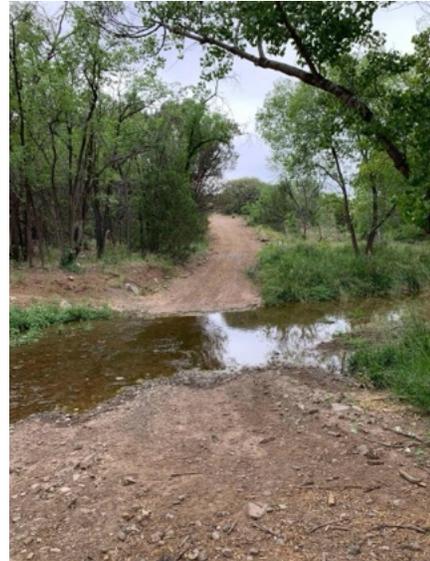
In this image, you can see that the road drains to the floodplain of the creek in the right of the photo instead of taking stormwater and its sediment directly into the stream.

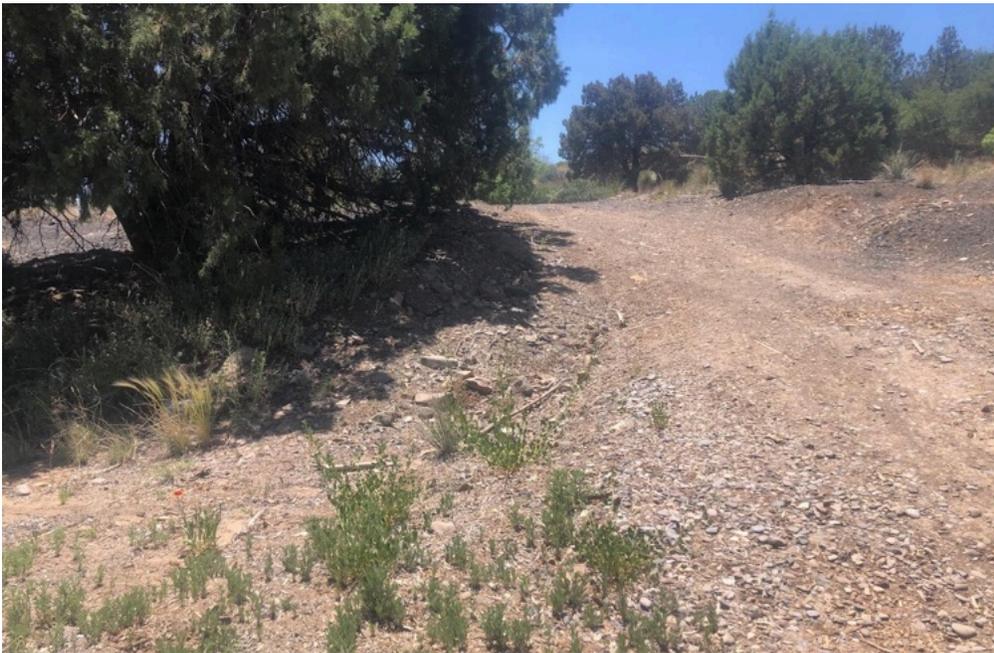
May 2024

In the photo below, which was taken higher up the road, you can see another rolling dip taking stormwater off the road to the viewer's left.

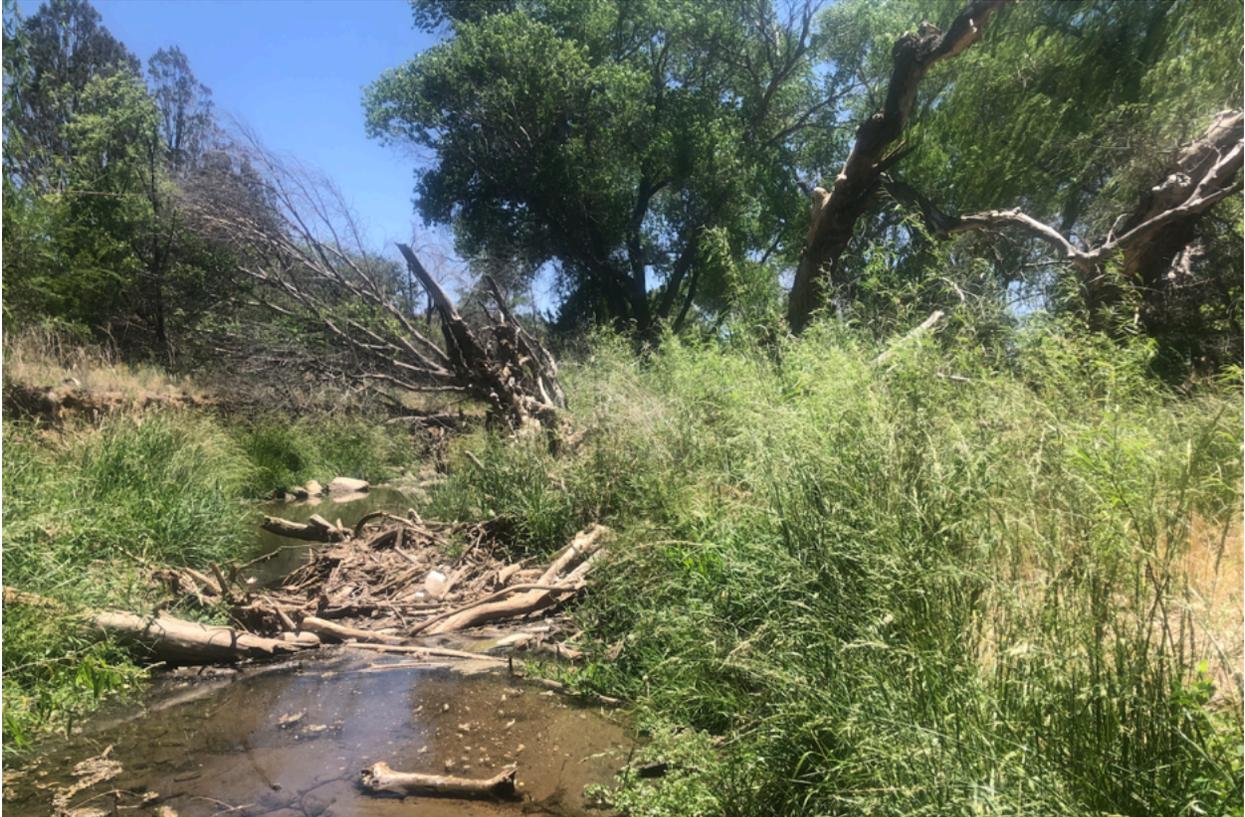
May 2024

The photo below shows the willows that Stream Dynamics pole planted on river right above the downed cottonwood. The willows are doing well. Years ago at this site, a cottonwood had rotated out of the left bank and blocked the stream by starting a log jam about 5 feet high. This backed sediment nicely up the creek and created pleasant Cienega-like conditions in the valley bottom for a few years before cutting to the left (away from the sewer fortunately), and starting a much-needed meander. Part of the tree is visible in the right of the photo. On the left is the cutbank on the outside of the new meander bend, which has now been slowed by encountering a few embedded boulders and another tree that the creek is slowly removing. In the meantime, our willow stand on the gravel bar on the inside of this bend is going to aggrade to bankfull stage over time, maintaining lateral pressure on the left bank.

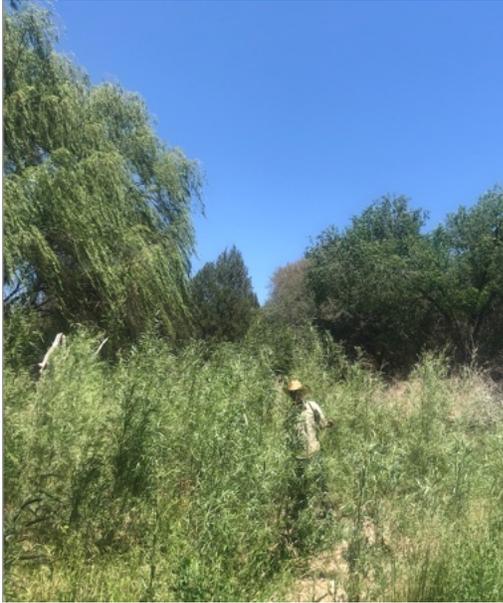
May 2024

The photo below shows the gravel bar below the downed cottonwood that we also pole planted with willows in October 2022. The willows are averaging about 6 – 7 feet high. The survival rate was over 95%. This feels like a tremendous success because the new thicket is already thick enough to influence sediment deposition, and this will continue to put pressure on the left bank over time. We are inducing meandering into that bank because the stream needs sinuosity, and the sewer is buried in the opposite bank here (river right). This willow thicket has radically increased Manning's  $n$ , which is the roughness factor. This will decrease the particle size that can be raked across this bar during a flood, thus causing the bar to aggrade. The willows will grow through this aggradation.

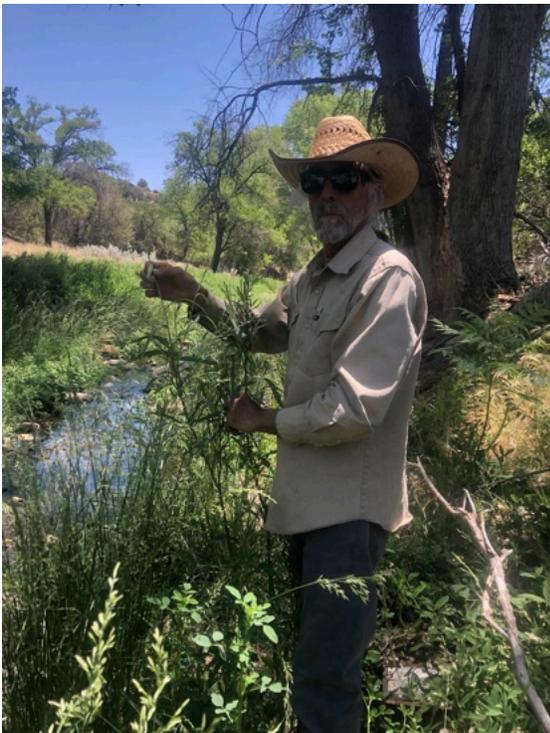
May 2024

In the photo below, last year's coyote willows averaged about 3 ft high all along the right river bank downstream of the gravel bar. This was difficult to plant due to the very stony bank and crowding by invasive tall fescue and sweet pea, but we believe we have finally gotten enough willow density here. Walnuts are also growing on the bank.

Note: this reach was only planted on river right because the sewer line is too close to the bank on that side and we need to protect against meandering towards the sewer line.

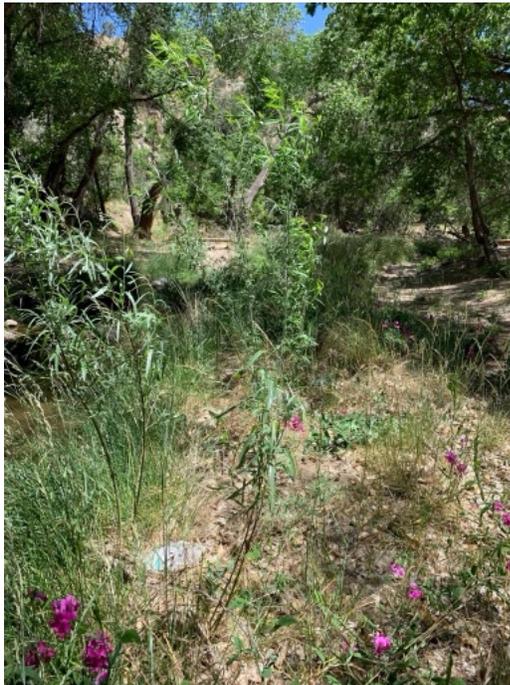
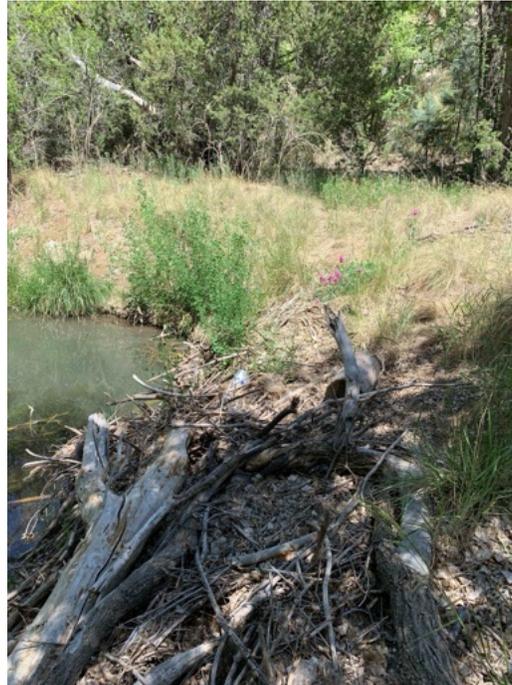
Willow whips were planted on the right bank in “The Jungle” as well as on the left bank at a sharp bend in the creek to the right. Willow plantings in this area didn’t do quite as well given the shady location and the invasive tall fescue and sweet pea that buried some of the willow whips. Whips planted at the bend also didn’t do quite as well as some were buried by flood debris.
