**Final Report**  
**San Vicente Creek River Stewardship Project Phase 1**  
**June 15, 2024**  
**Submitted by Gila Resources Information Project**

**GRIP San Vicente Creek Restoration Project  
GRIP Phase I Management Units  
(svc001-011 & AgA001)**

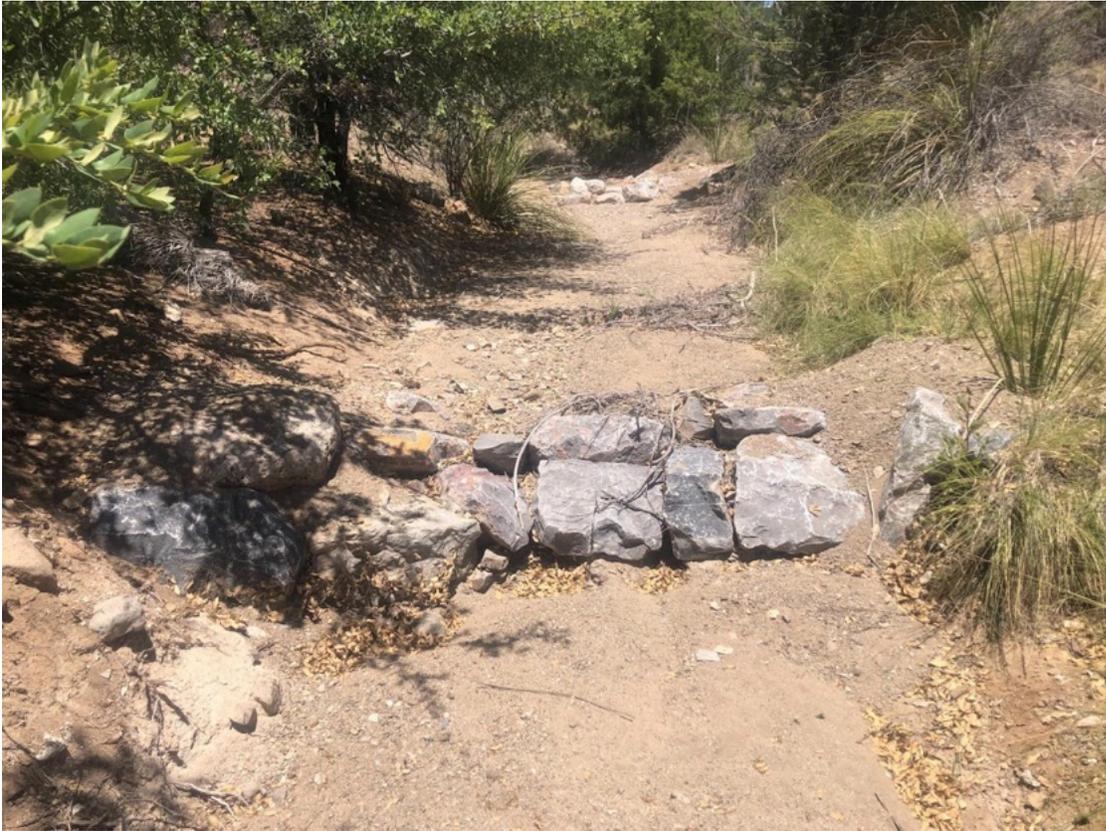
May 2024

In the photo below, looking upstream in Agave Arroyo, you can see that this structure has filled in nicely with coarse sand and gravel behind it. This creates the sponge of porous sediment on top of the shallow bedrock.
